Annual Inspection Report Gragg-Wade Field Airport

# **ANNUAL INSPECTION REPORT**

NOVEMBER 5, 2010

CHILTON COUNTY (GRAGG-WADE FIELD) AIRPORT CLANTON, ALABAMA

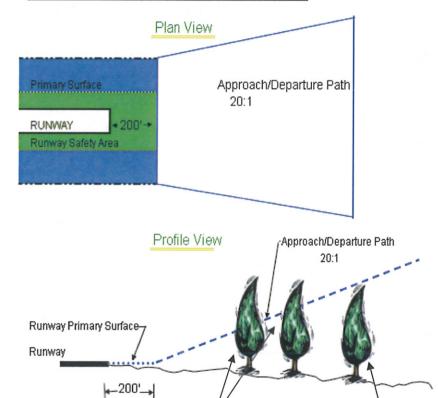
**APPENDIX 1**

Approach and Departure Path Dimensions				
Inner	Outer			
Width	Width	Length	Acreage	
250 Feet	450 Feet	1,000 Feet	8.04 Acres	
Primary Surface Dimensions				
250 Feet Wide Centered Along Runway Centerline				
Extending 200 Feet Past the Runway End				
Runway Safety Area Dimensions				
120 Feet Wide Centered Along Runway Centerline				
Extending 200 Feet Past the Runway End

No Obstruction
